Agence Nationale de Sécurité Sanitaire (ANSES) –  
Hearing on the Operation of Air Conditioning in  
Aircraft Cabins and the Associated Air Quality

Dieter Scholz

Hamburg University of Applied Sciences

## Air Conditioning in Aircraft Cabins and the Associated Air Quality

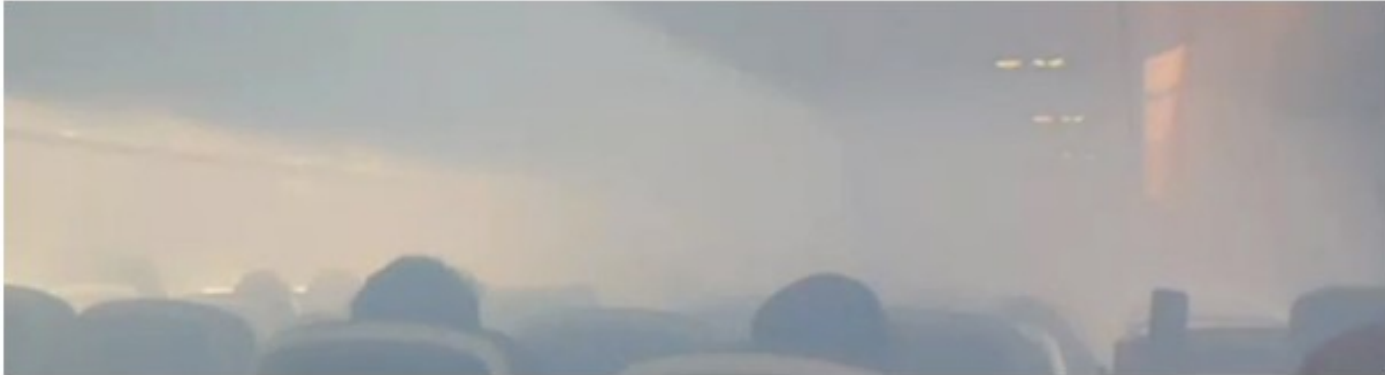
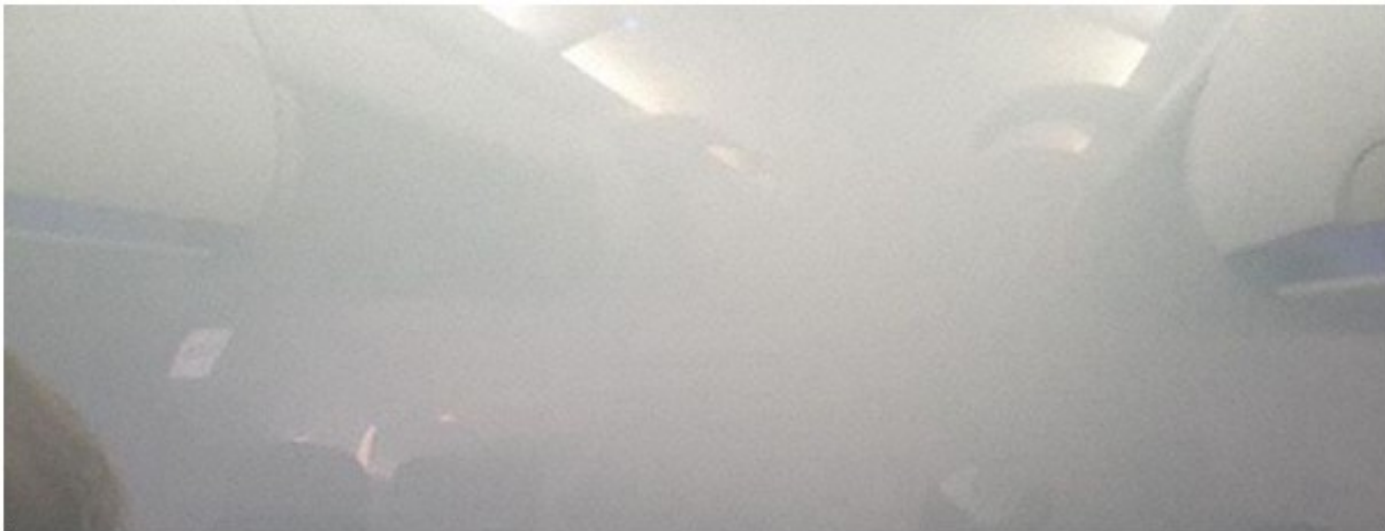
Top:2019-08-22, Hawaiian Airlines HA47, A321neo.

Bottom: 2019-08-05, British Airways BA-422, Airbus A321 (<https://youtu.be/tFsN0h09gAI>).

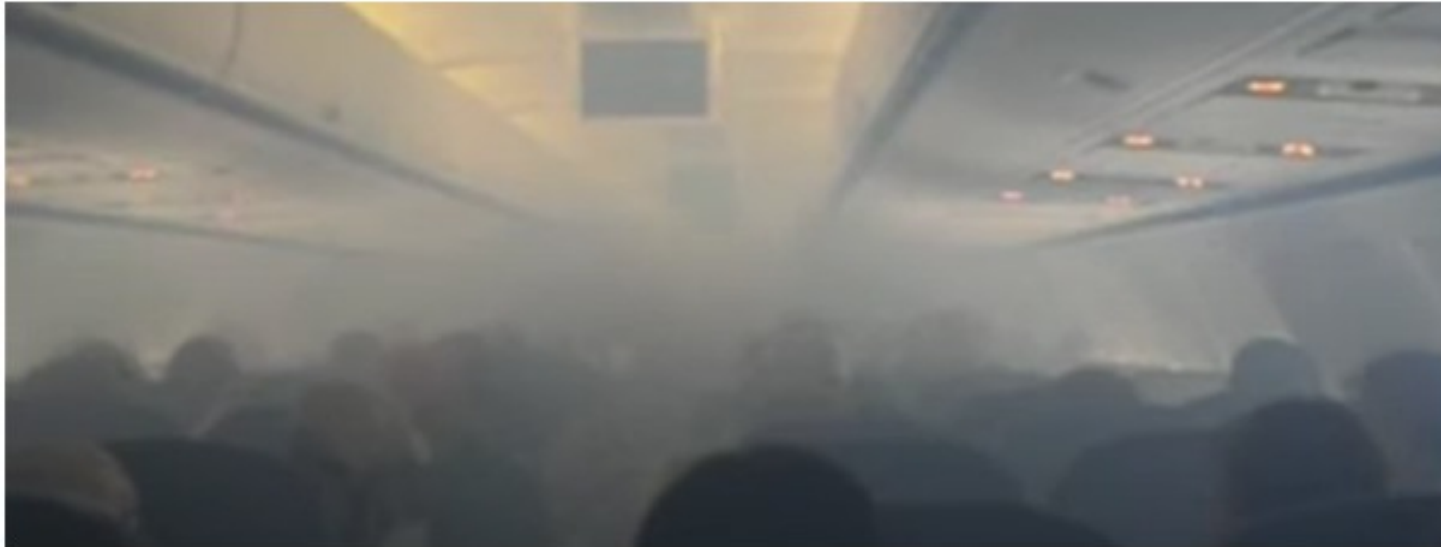
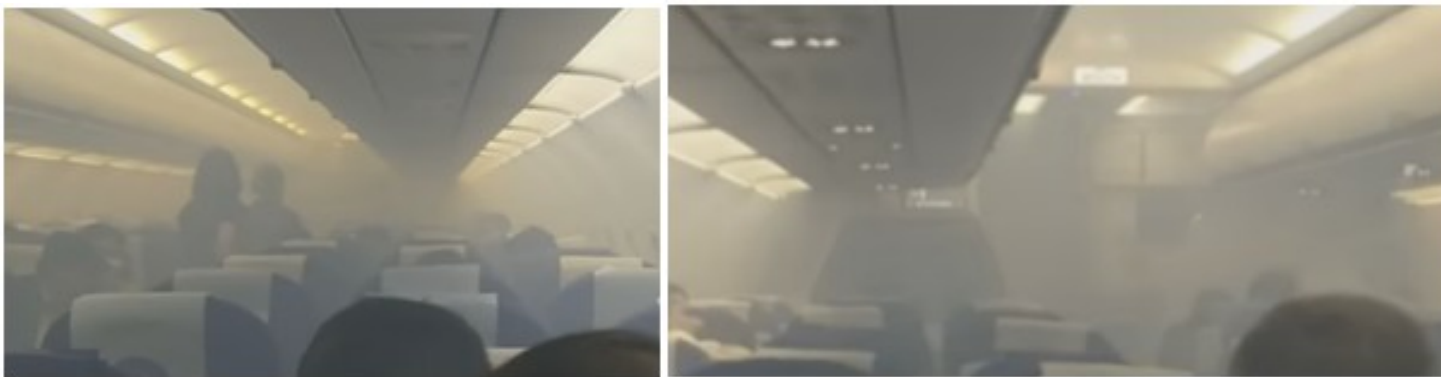
Top: 2010-09-17, US Airways US-432, Boeing 757-200 (<https://youtu.be/AZqeA32Em2s>).

Bottom: 2018-12-10, Indigo flight 6E-237, Airbus A320neo ([https://youtu.be/TO\\_FZ3L4yus](https://youtu.be/TO_FZ3L4yus)).

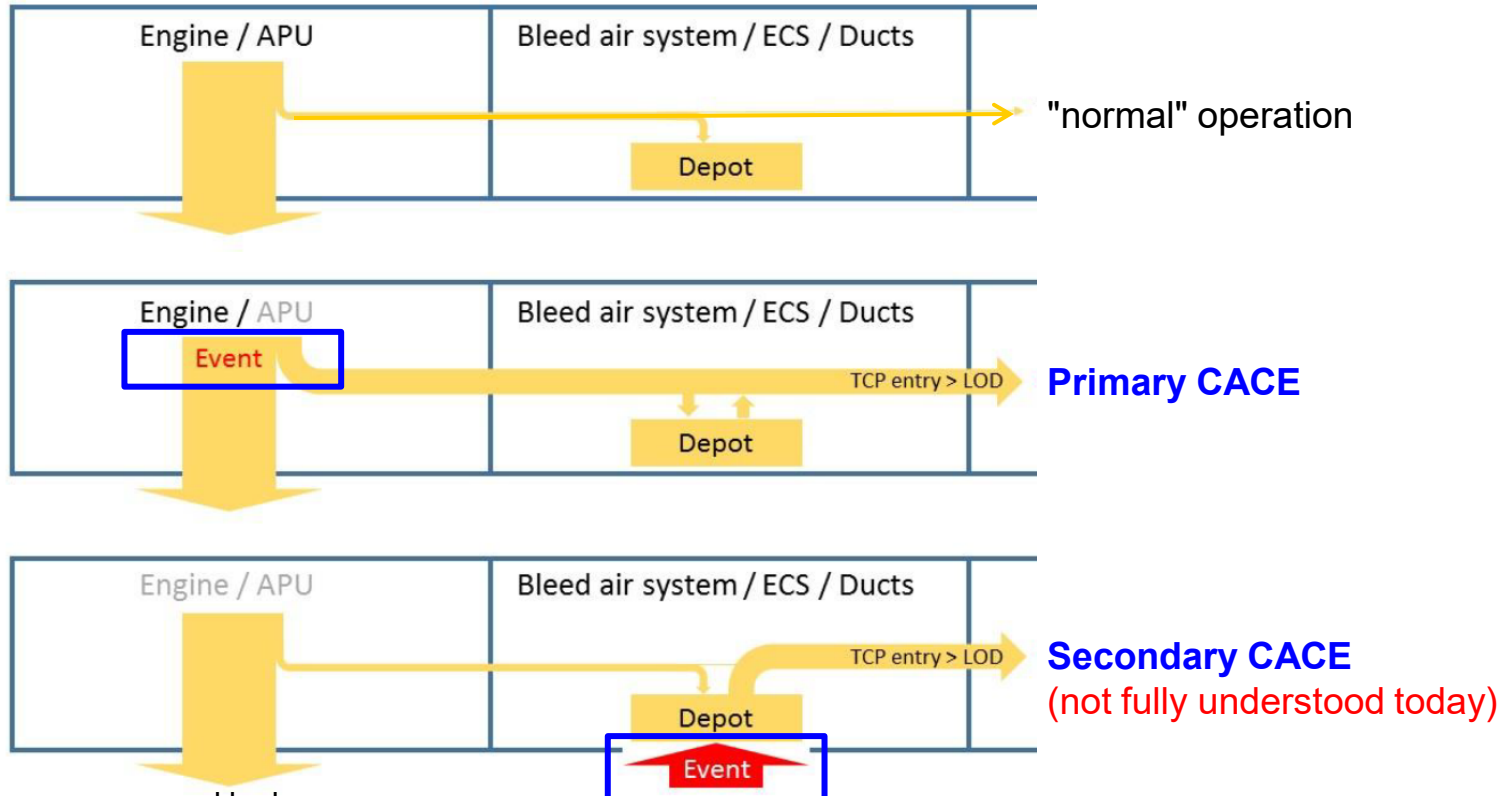
### Event Mechanism:

- normal leakage
- seal failure
- neg.  $\Delta p$  in bearing chamber
- transients

- mechanical stress?
- thermal stress?
- solvents (water, de-icing fluid, ...)?

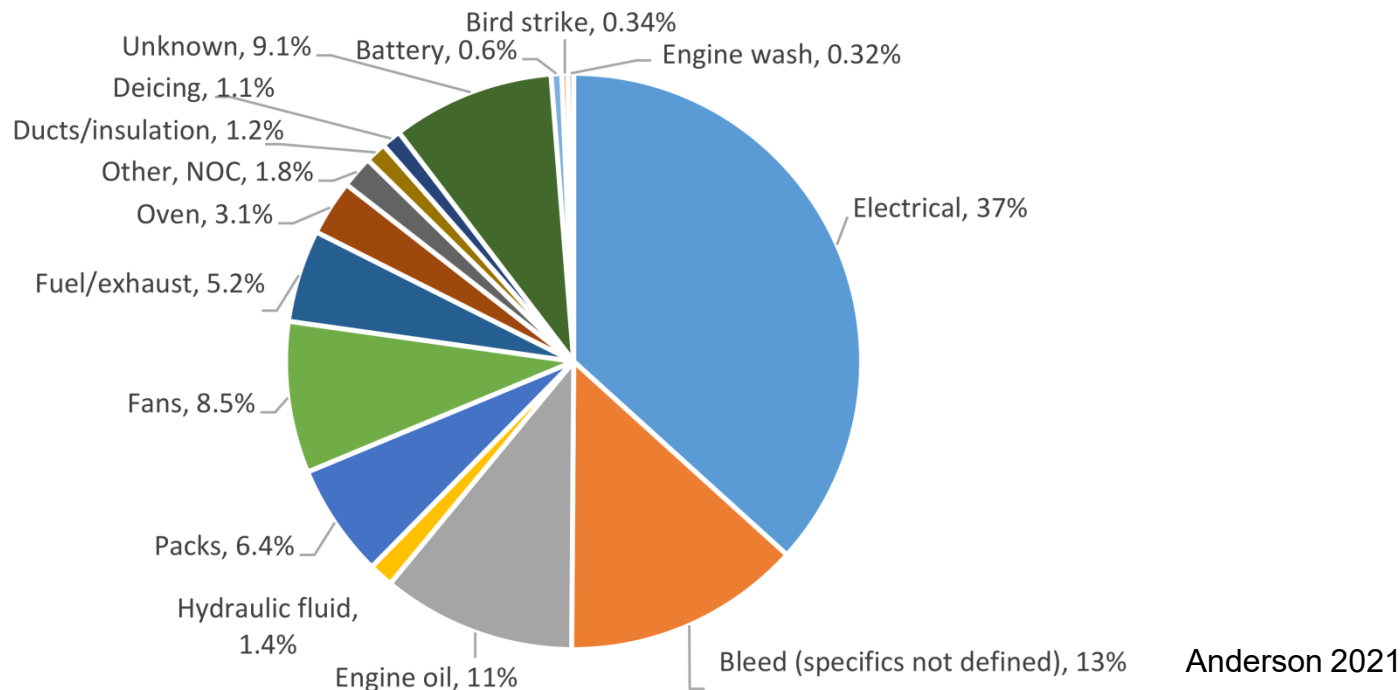
Onboard Fumes/Smoke Reported by U.S. Airlines total 12452 events of different source. The objectionable classical cabin air contamination from **"bleed"**, **"engine oil"**, **"hydraulic fluid"**, and **"deicing"** **accounts together for roughly 1/3** of the events. Industry often quotes "oven" as the main reason, but it only accounts for 3.1%.

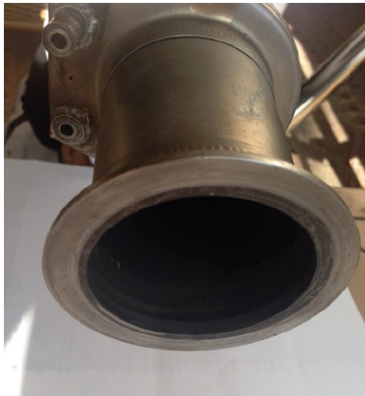
1. (GCAQE 2017)

1. Oil traces in **bleed air ducts**
2. Oil traces in **air conditioning ducts**
3. Oil traces in **recirculation filters**
4. Oil traces on **cabin surfaces** (wall panels, seats, ...)
5. Hydro carbon concentrations in the cabin can be **calculated** and agree with measurements

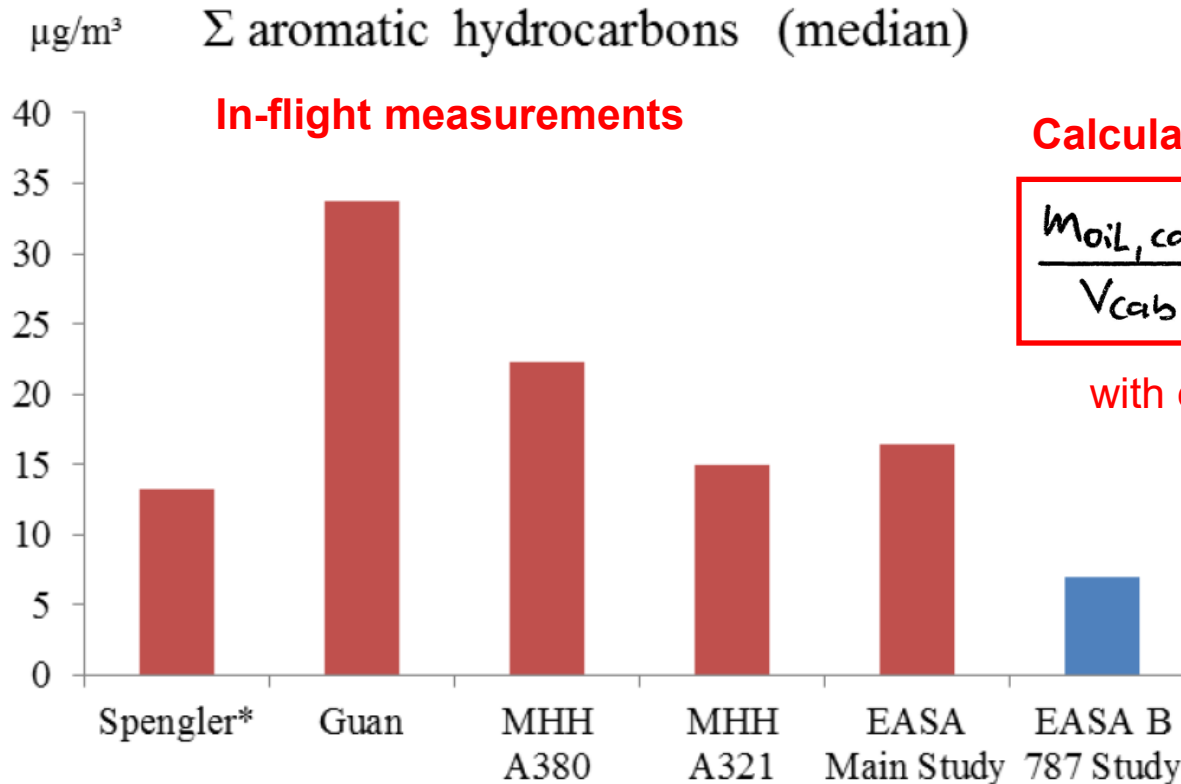
**Calculated:**

$$\frac{m_{oil, cab}}{V_{cab}} = 17 \mu\text{g}/\text{m}^3$$

$\Sigma$  aromatic hydrocarbons, comparison of different studies (median);

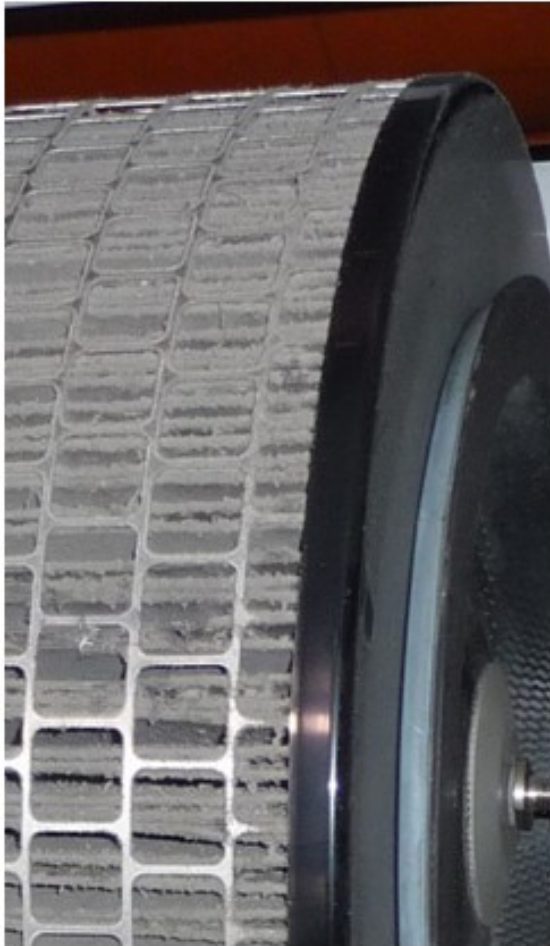
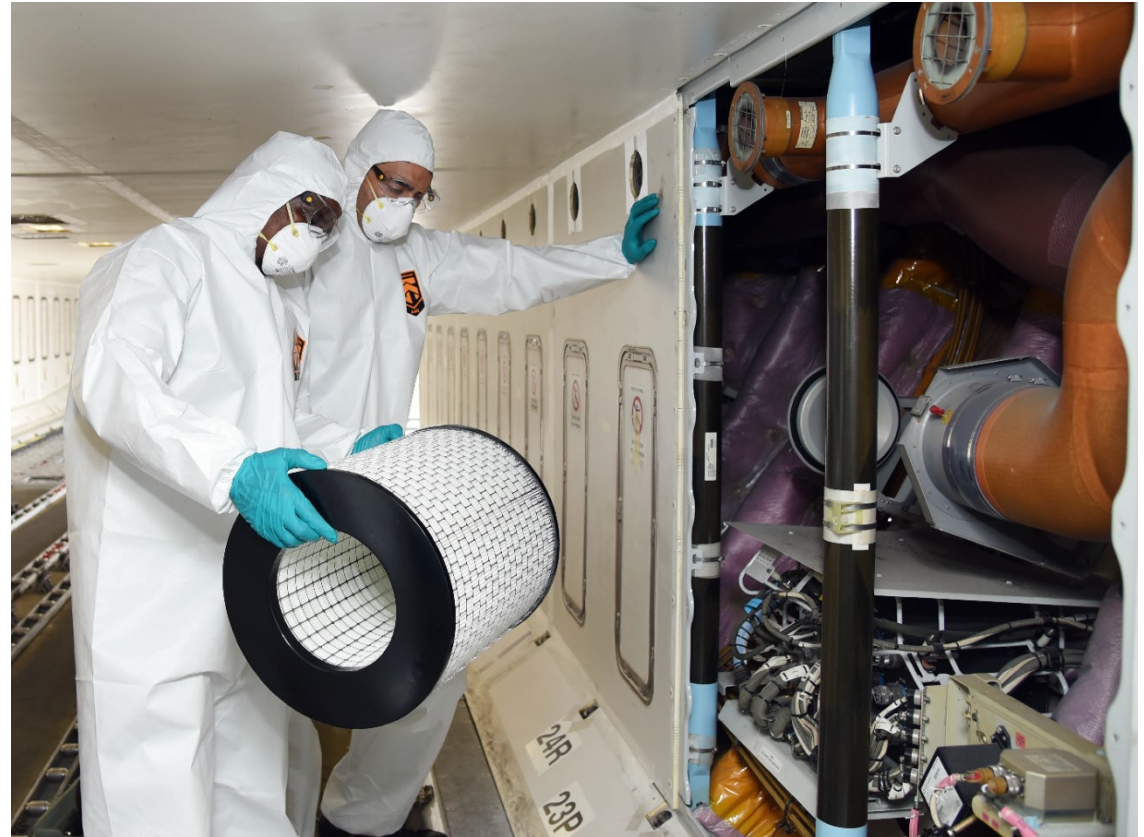
# HEPA Filter

A380, Emirates

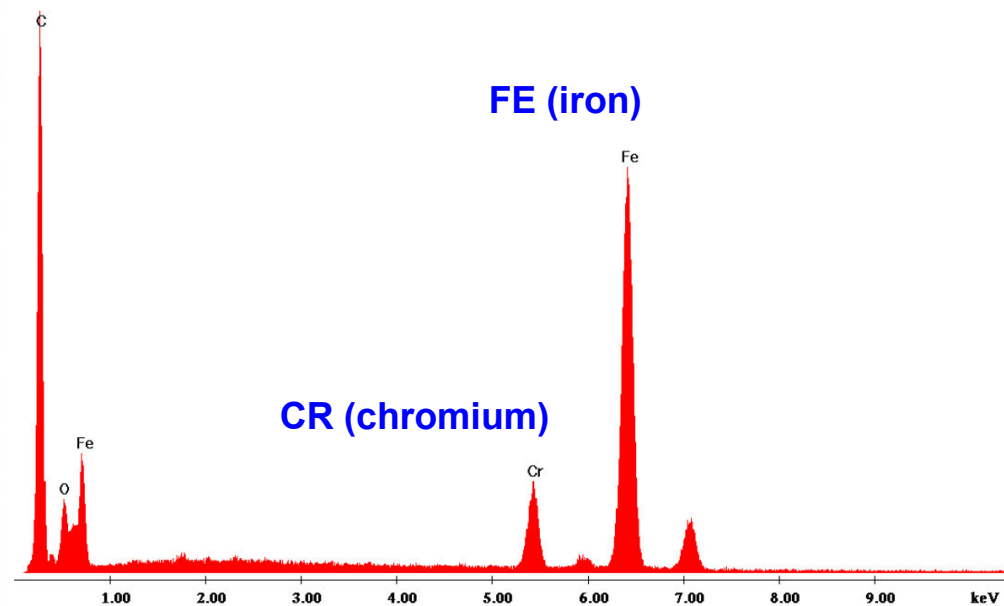
Analysis 8 of Table I. High-magnification image (1228x) and EDS spectrum of 10-micron and 1-micron brighter-looking particles composed of Carbon, Iron, Chromium and Oxygen: a stainless-steel composition. EDS: Energy-Dispersive X-ray Spectroscopy.

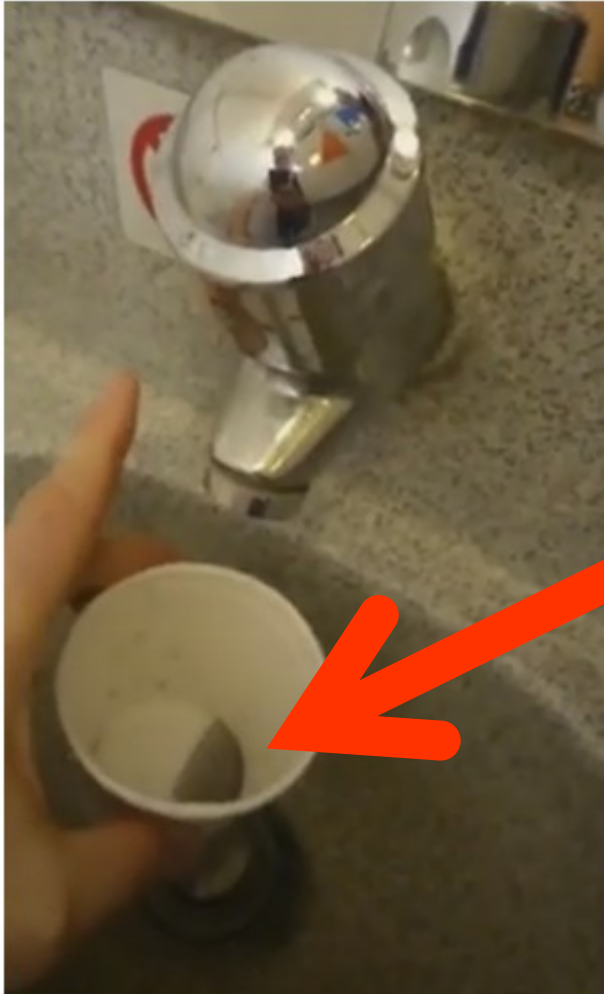
Potable water contaminated by bleed air on an Airbus A320. The last **water** extracted from the tank before it is empty is **black**, probably **from engine oil residue**.

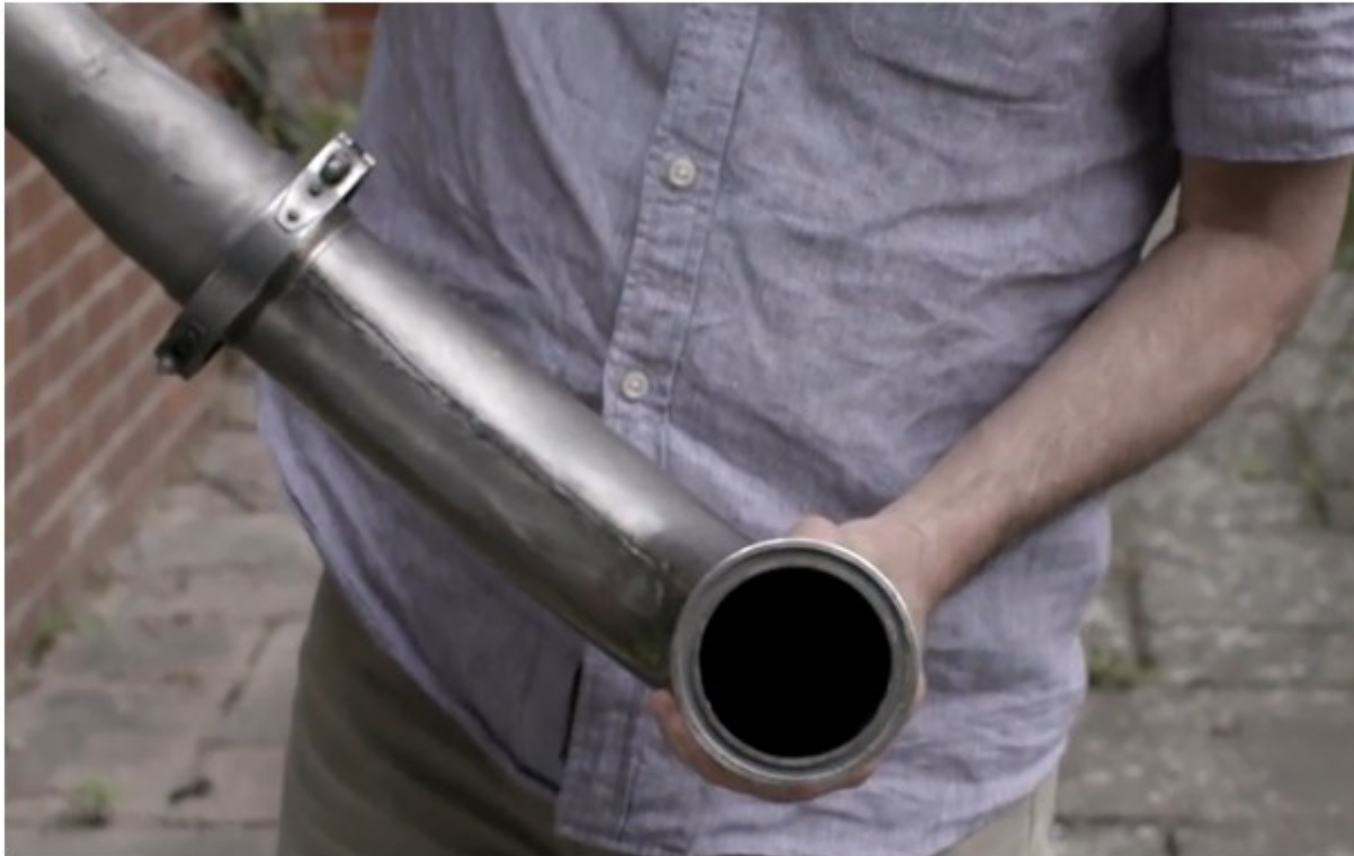
Bleed air duct of a Boeing 737 with **black oil residue** inside. Air temperature of about **200 °C**.

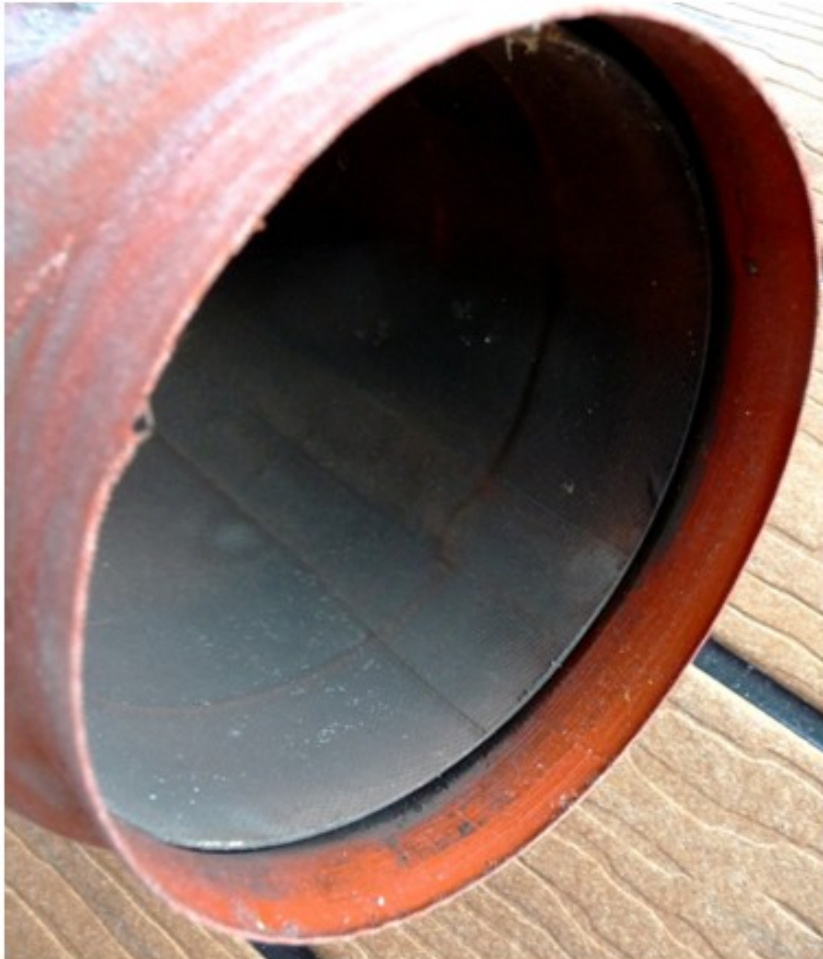
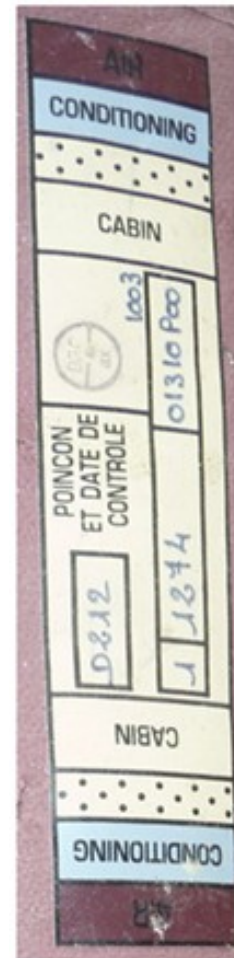
Airbus A320 air conditioning air distribution duct in the cabin. The inside is black from contaminated bleed air.

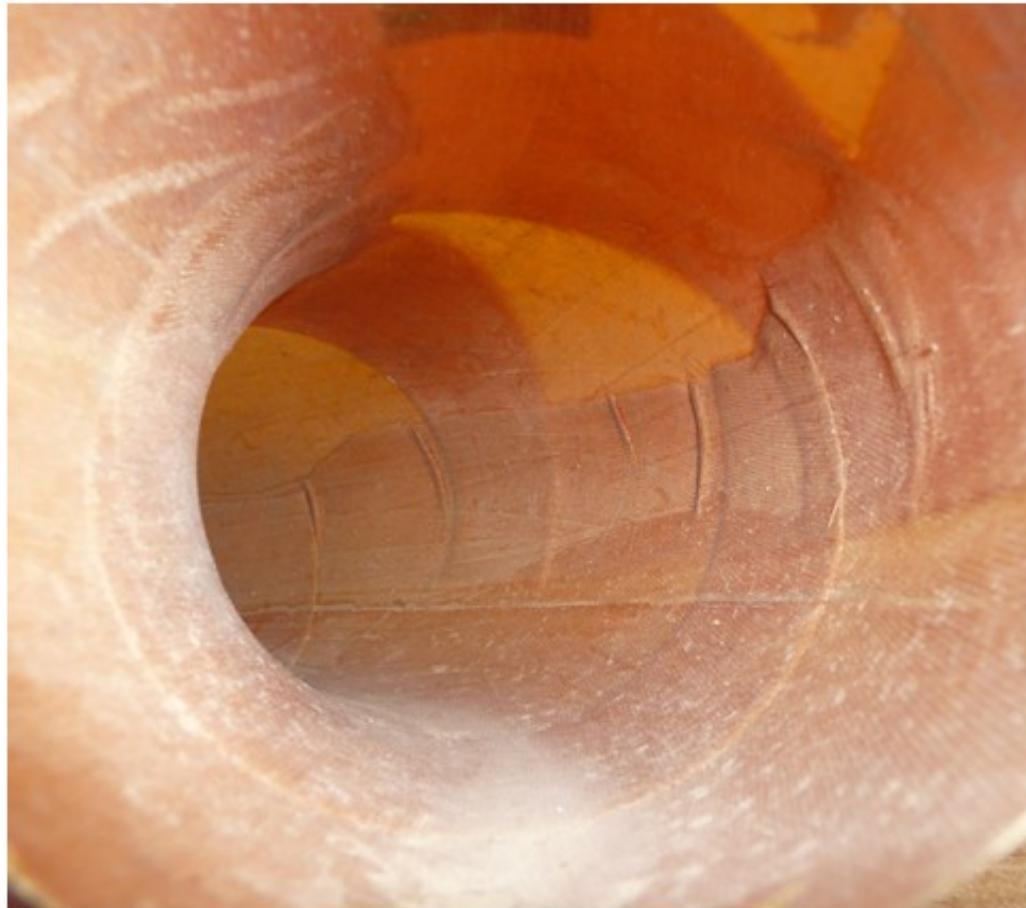
The inside of the air extract duct (located near the extract fan) is **clean** at the end of life of an Airbus A320, **because** the duct is normally **not fed with bleed air**.

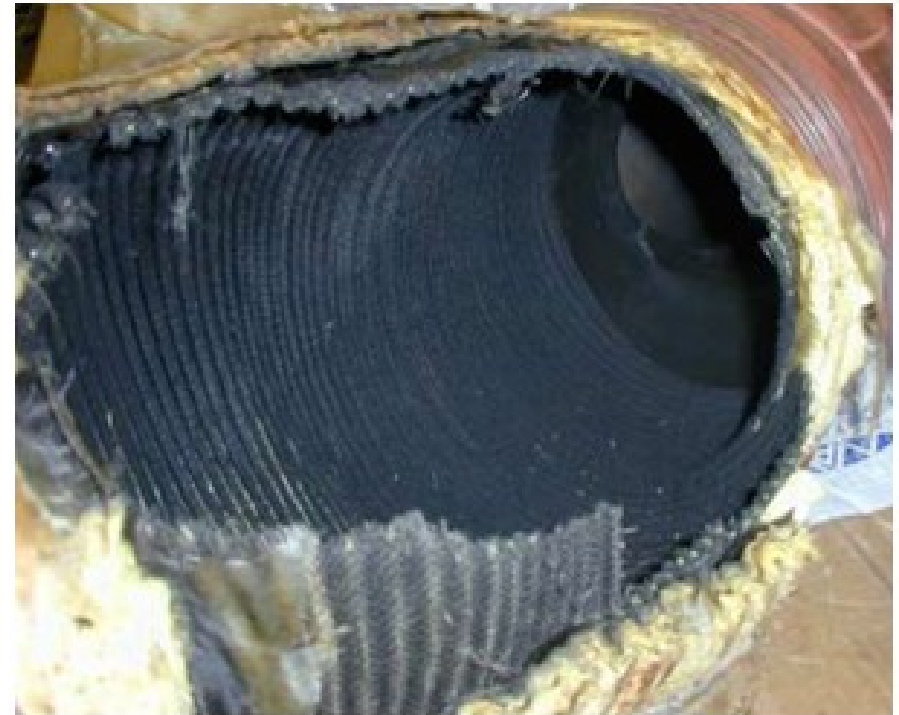
Left: A unused duct supplied new.

Right: A ducts that had been installed downstream of the environmental control system air conditioning packs on a BAe 146 passenger aircraft after 26061 flight hours (CAA 2004).

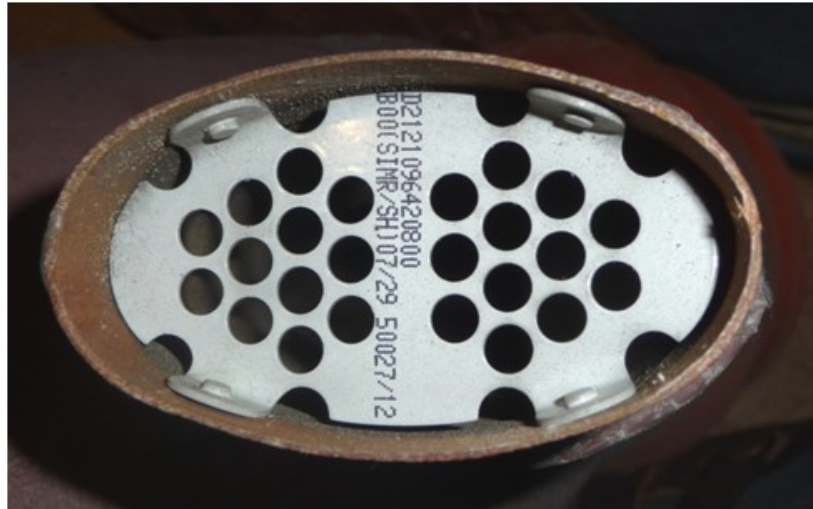
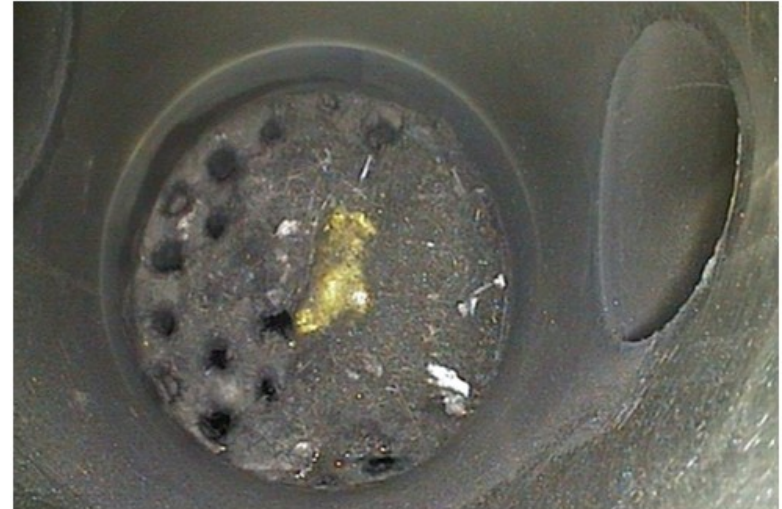
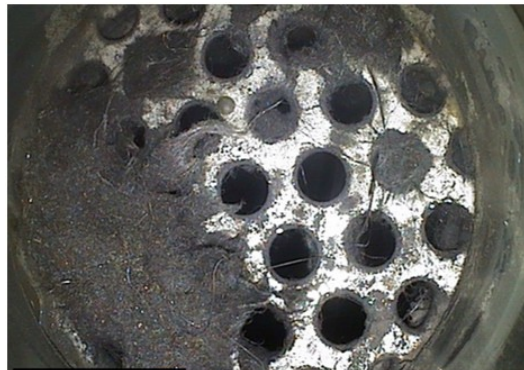
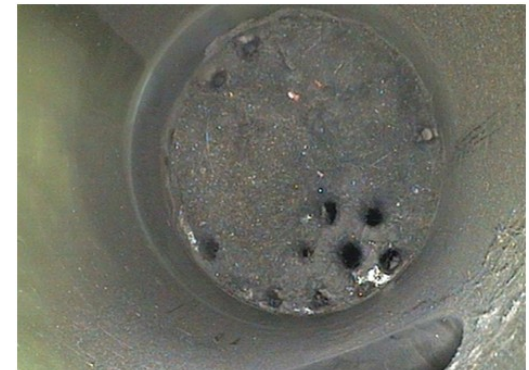
Flow limiter clogged from pyrolysed engine oil in ducts of the air conditioning system of Boeing 757 aircraft with Rolls-Royce RB211-535E4 engines operated by Icelandair (Hansen 2019) compared to a clean flow limiter (top).

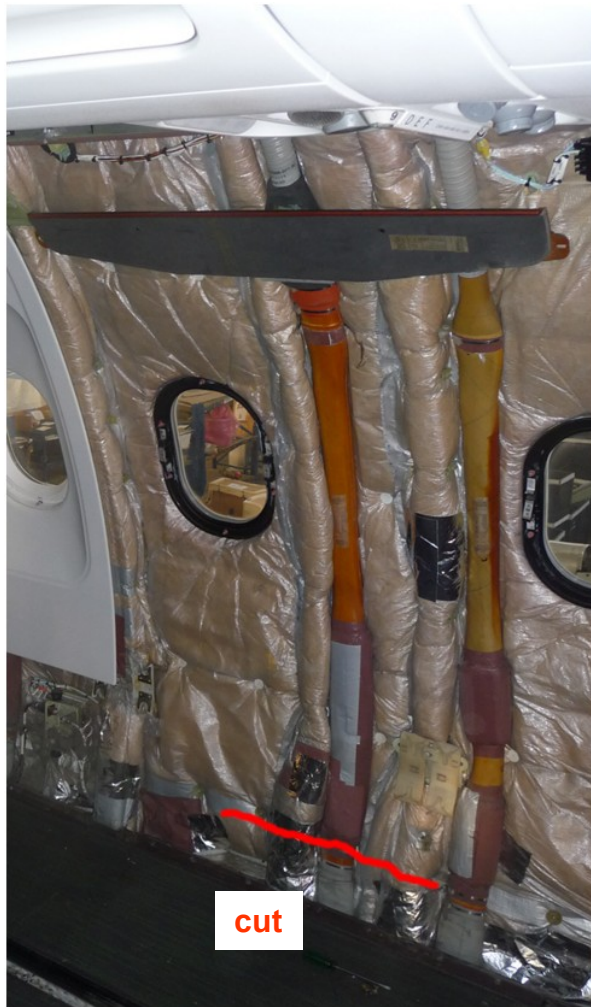
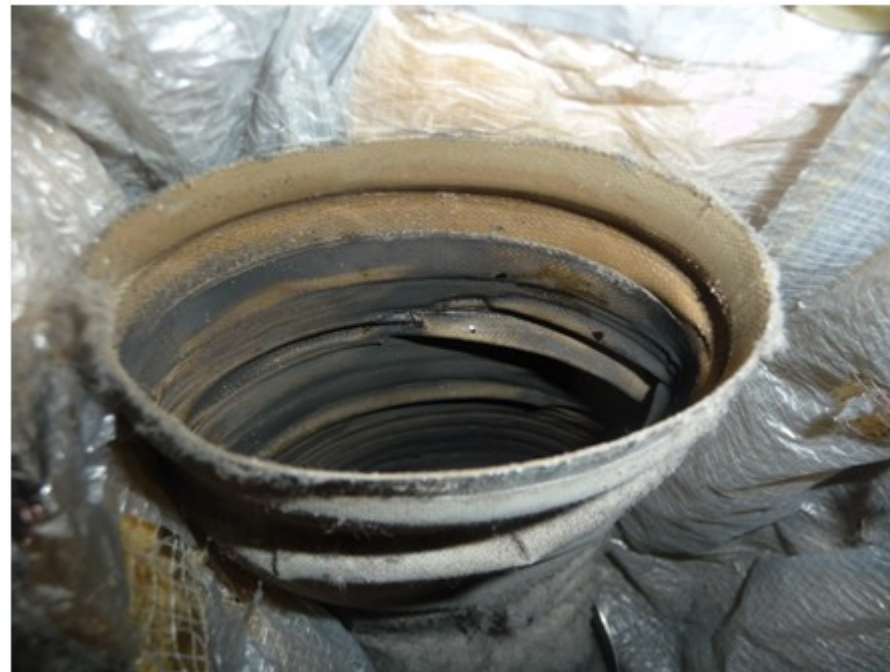
Riser ducts and lower cabin air outlet on an Airbus A320 aircraft. The red line close to the cabin floor shows, where the duct was separated and opened. It is black inside from engine oil residue.

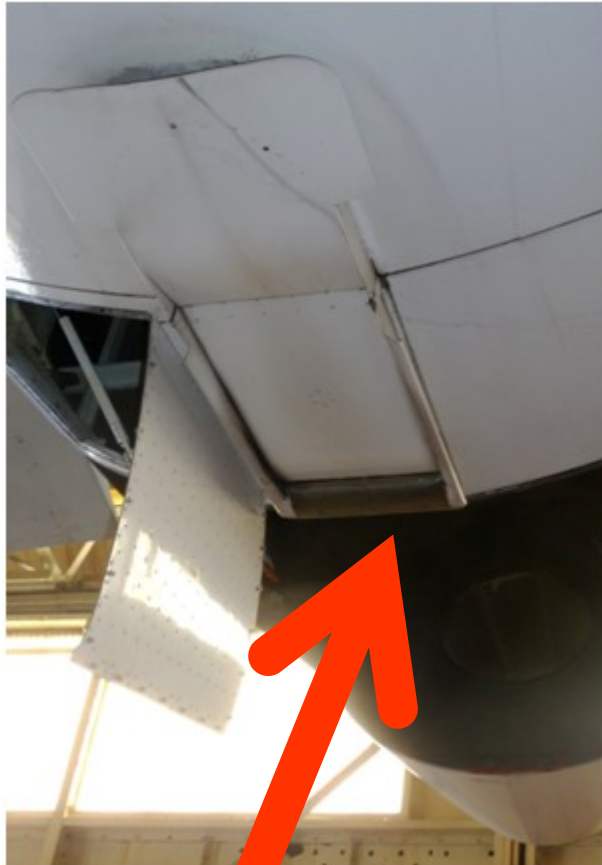
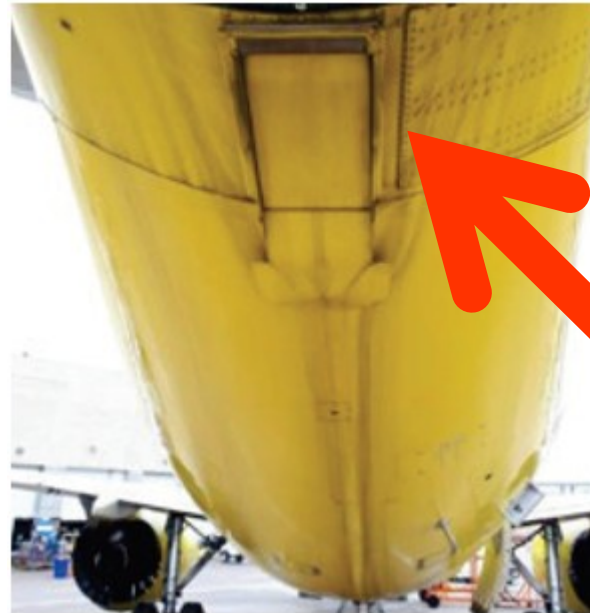
Left: Air intake of the A320 APU. Fence and deflector around the APU air intake are clearly visible. These measures cannot fully prevent contaminants from entering the APU. Right: **Traces of contamination are clearly visible on the lower part of the fuselage. Carried by the air flow in flight, the contaminants reach the APU inlet.** Source of picture on the right: Airbus 2019.

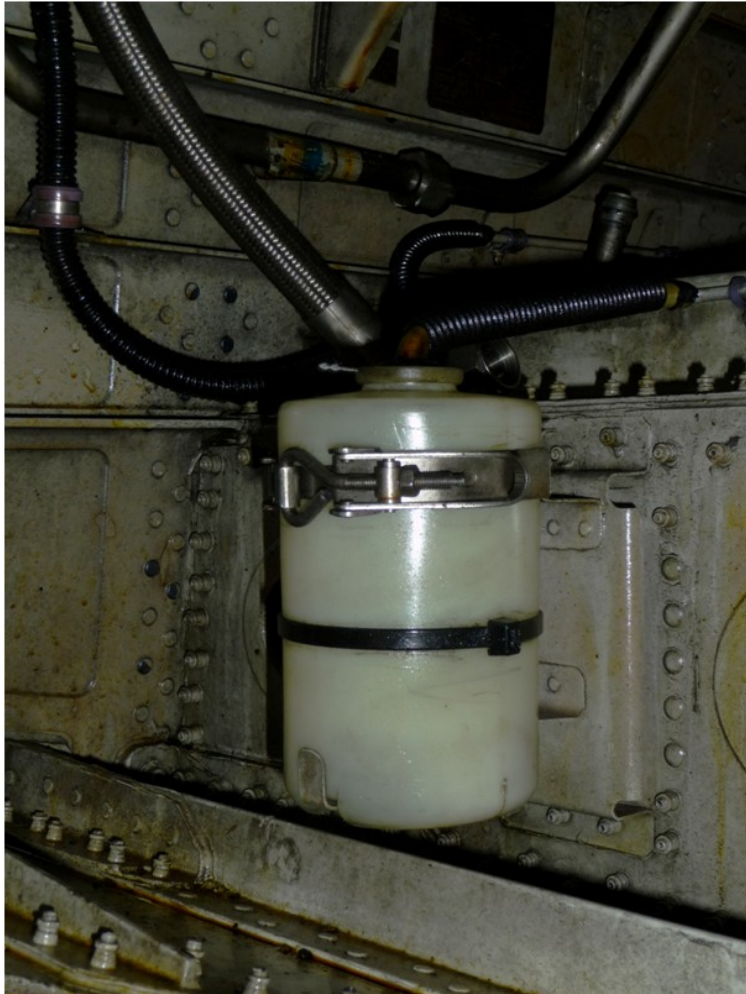
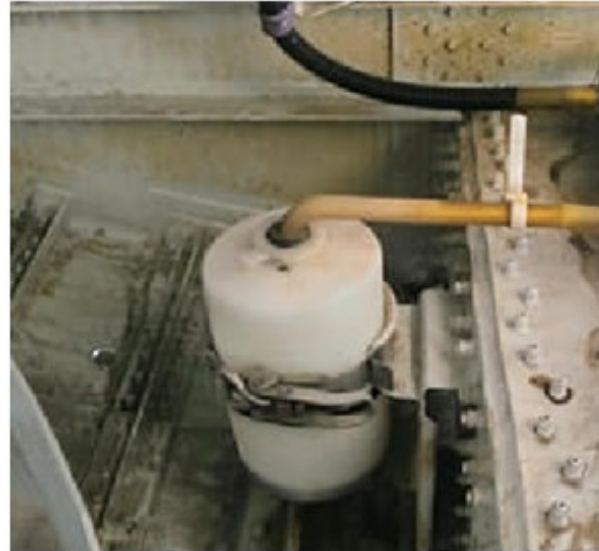
Aft collector tank of the A320 hydraulic seal drain system. In this old Airbus A320, **all surfaces** in the landing gear bay **are covered with a layer of hydraulic fluid**. Dirt accumulates on the sticky surface. **The hydraulic fluid is not confined to the inside of the hydraulic bay, but continues its journey on the lower side of the fuselage towards the APU inlet** (previous page).

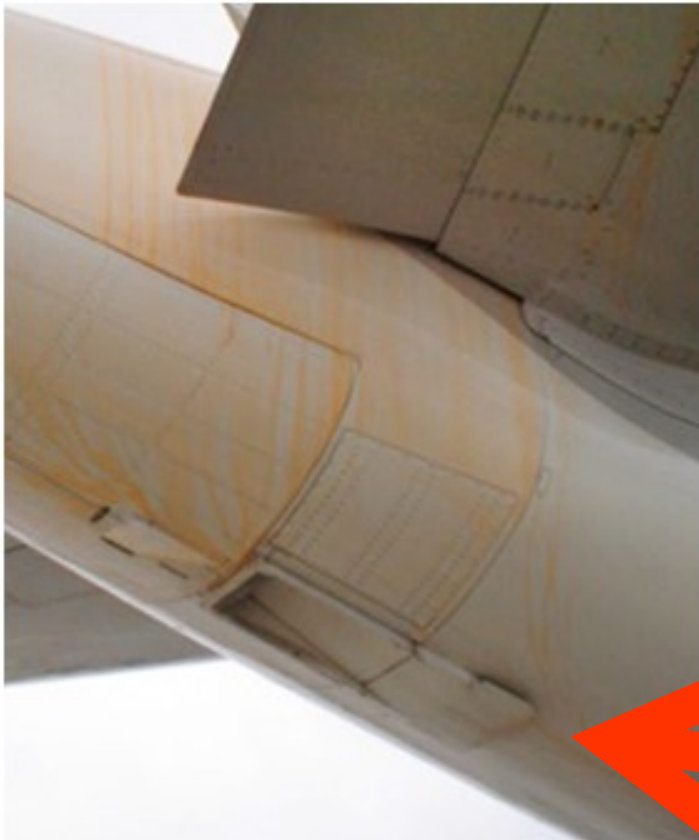
Deicing Fluid Leaks from the Tail into the APU Inlet

Vera-Barcelo 2013

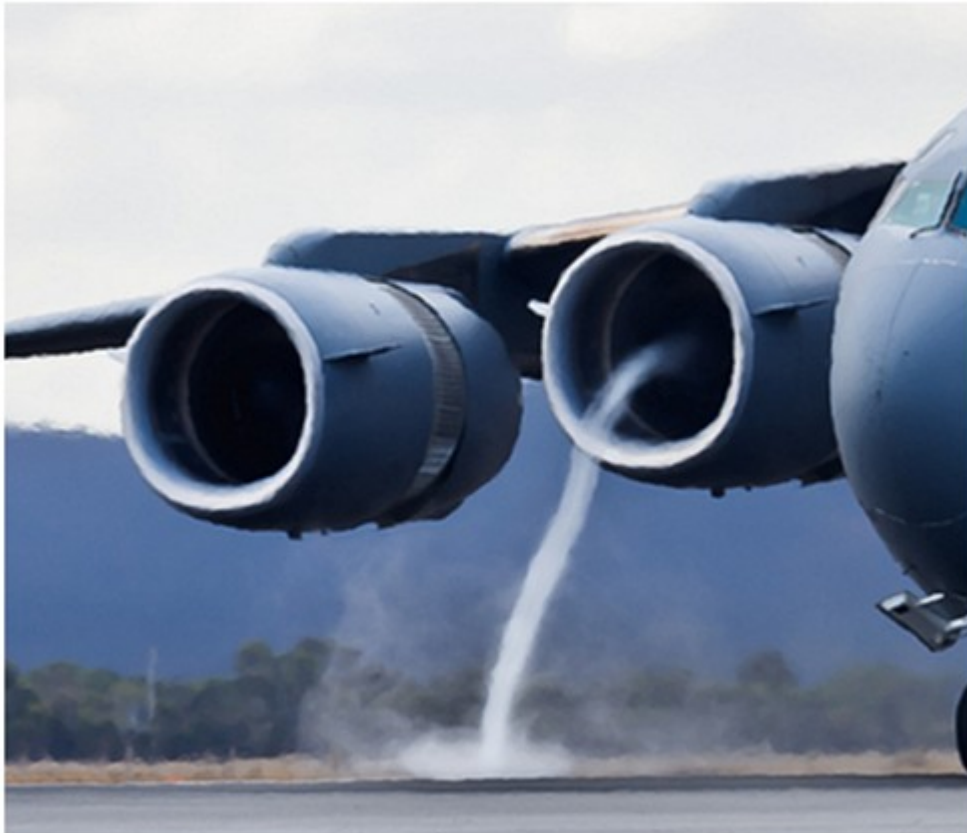
The ground vortex can also form between the ground and an engine on a high wing (Childs 2017).

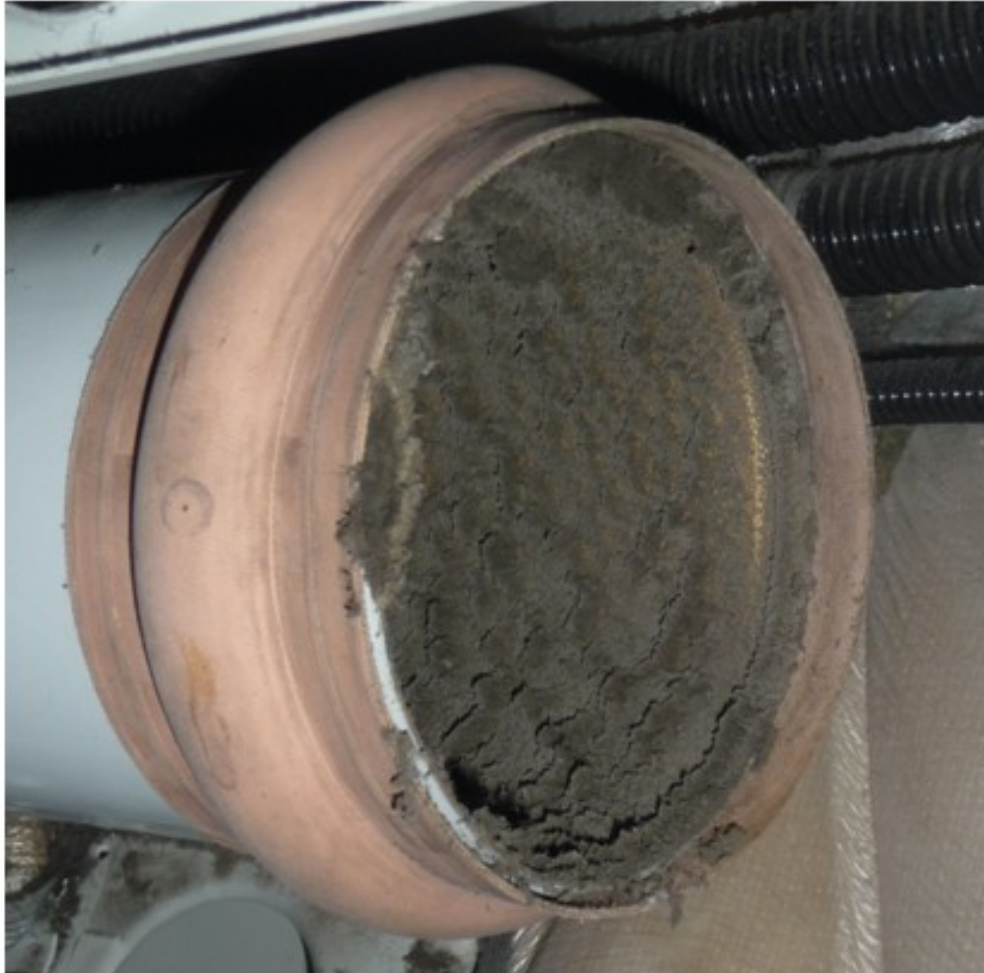
The ambient air inlet in the cargo compartment of the Airbus A320 for **cargo compartment heating** and ventilation. The inlet is full of **moist dust**.
